Planking problems

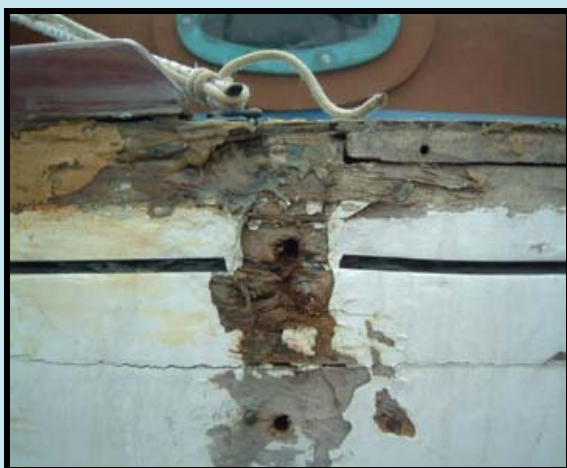
This occurs around rigging chainplates, any external attachment to the planking where water can be present but unseen and, the sheerplank where deck leaks will often affect the top a few inches for the full length.

Decay under chainplate extending into deck

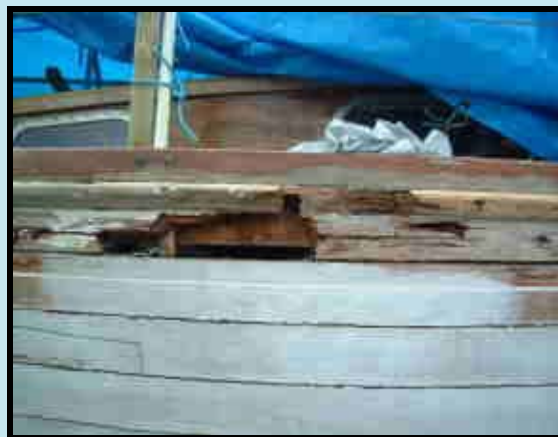
Major sheerplank decay caused by leaking deck

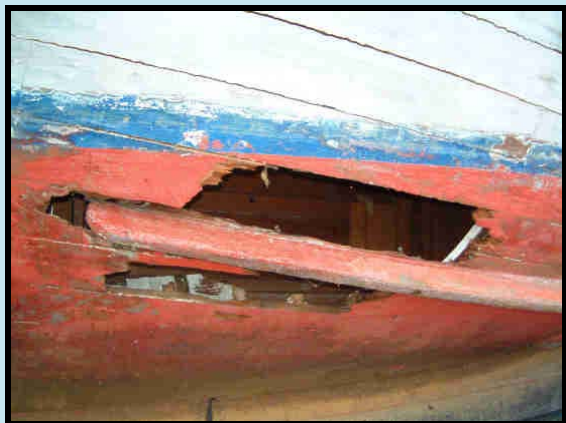
Rotten planking below waterline, in this case the vessel moored for many years in fresh water

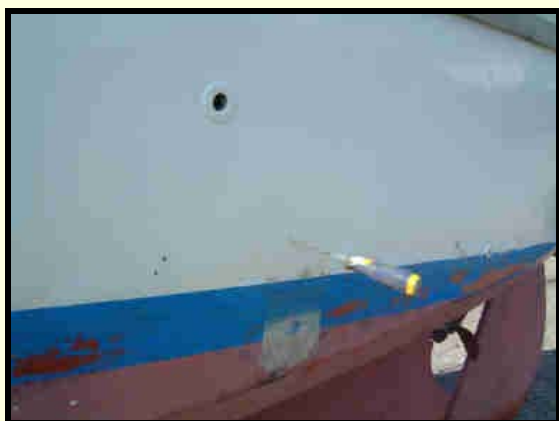
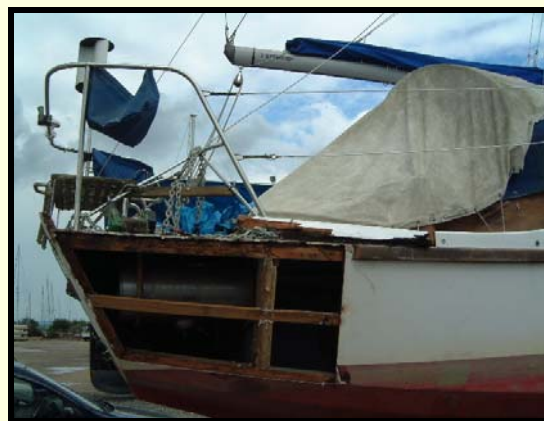
The same Golden Hind at different times, on the left the stbd side showing softening & delamination, and later exactly the same problem on port fully exposed and being repaired.

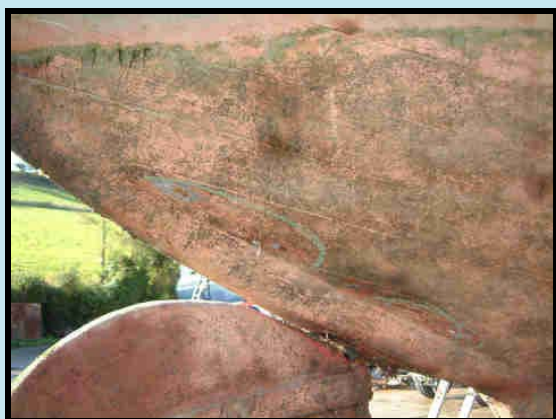
The hood ends are showing slight electrochemical softening surrounding the copper fastening that is likely touching the galvanised rudder tube & scarf bolt

Another problem that occasionally affects the fastenings is when a copper fastening passing through the hood end contacts one of the scarf bolts as these are completely hidden. When different metals are in contact, in seawater, this will create an electrolytic cell which, as noted earlier causes damage to the timber local to the fastening and, it will often be found that the planking at the point of the fastening is softened

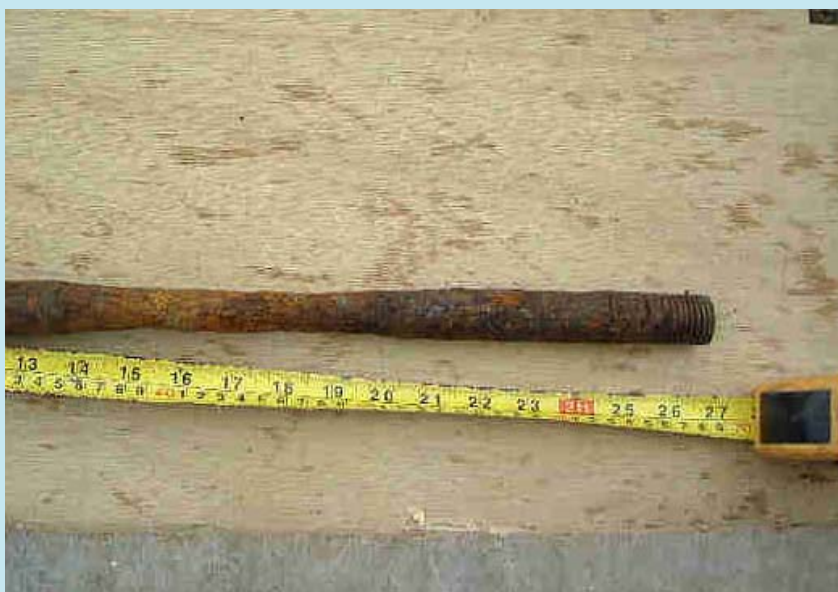
A 1" diameter keelbolt with a degree of "Waisting"

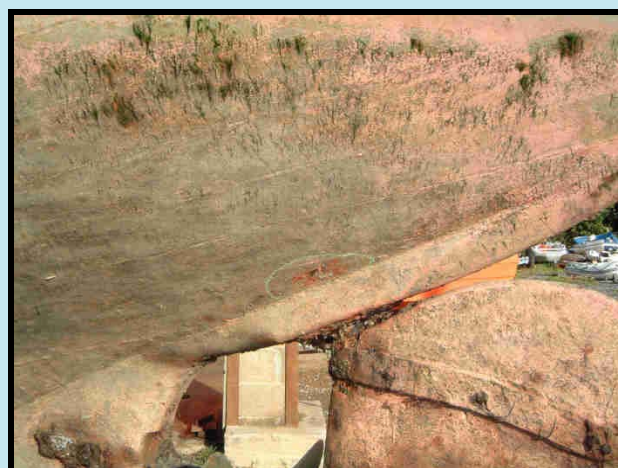
Here a copper nail is touching the rudder tube and softening the timber around the fastening end on the hood end
