Cored decks (and hulls)

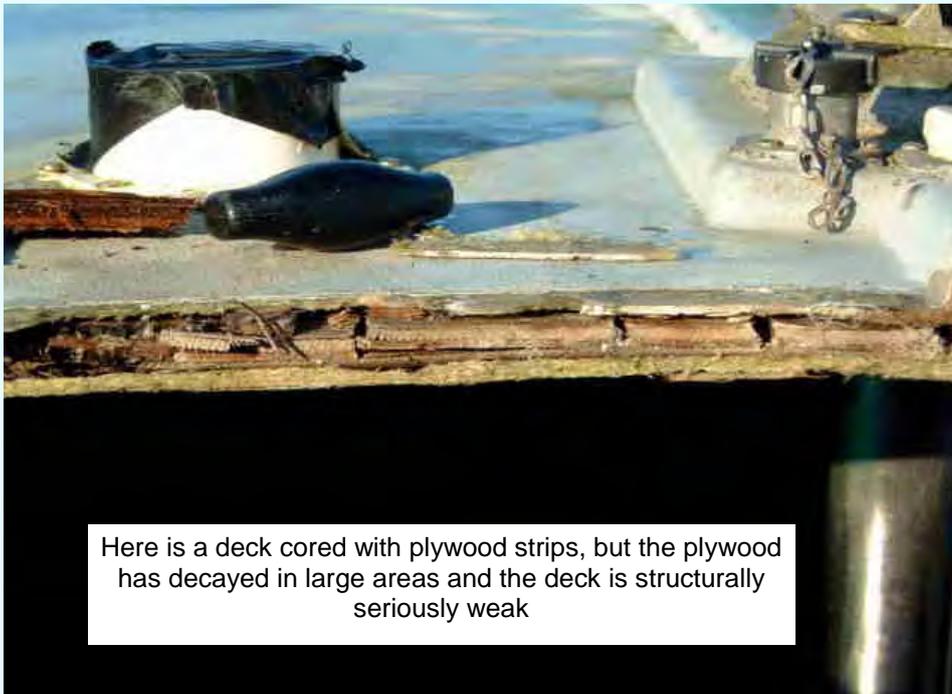
If a high presence of water has entered the core from leaks on deck, this can cause breakdown and failure of the core. Always ensure that deck fittings are maintained and any areas of strain or damage are attended to that may allow water into the core. In the case of serious breakdown of the inner core, whether it be balsa wood, polyurethane foam or plywood there is no option other than complete removal of this core.

Here is a deck cored with plywood strips, but the plywood has decayed in large areas and the deck is structurally seriously weak

This section is then completely removed and full access to the underlying core can be made. Once reparations to the core are complete depending upon the type of core present, the outer section of deck will be refitted and overlaid with epoxy resin and glass cloth along the boundary-connecting join.

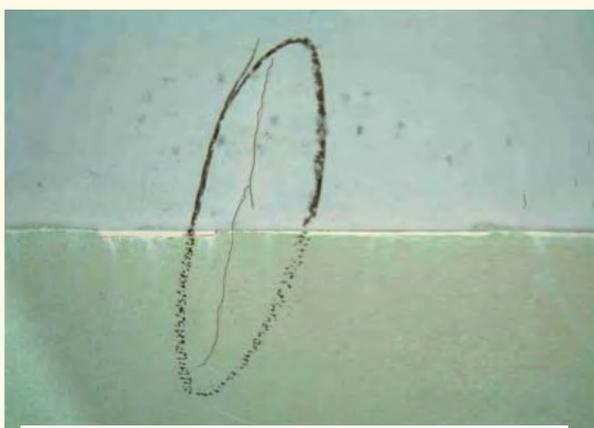
The usual cause is the hull flexing over internal assemblies such as a berth support or something similar.

Longitudinal crack in gel coat on waterline.
This should be further examined

Again, these should be considered structurally important and worthy of further attention and/or repair.

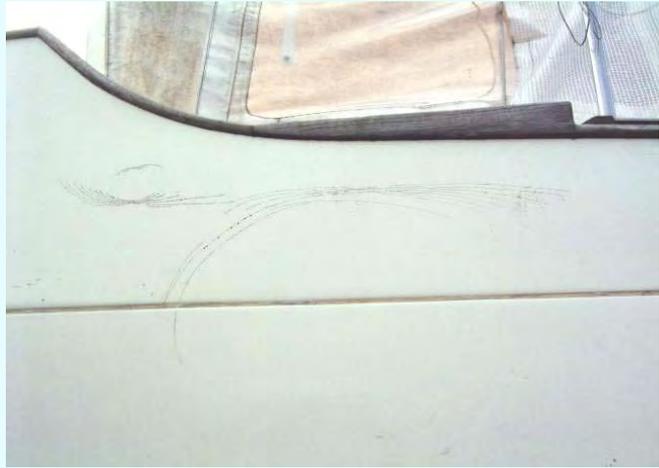
When the hull flexes, as nearly all do to a degree, the hull can hinge over this hard item and cause a crack in the gel coat and occasionally the laminate. The usual cause of this is fender loads when the fender is located a short distance either side of the stiffener or bulkhead.

Hard spot cracking over the edge of the sidedeck which is level with the horizontal cracking

If the loadings are severe such as can be caused by gales alongside in harbour with other vessels either side, the squeezing effect is considerable, flexing the hull and causing damage. Always ensure that fenders are located on bulkhead positions to minimise hull flexing.

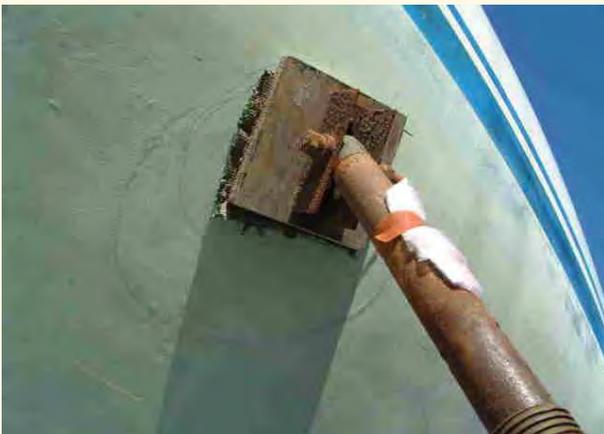
Not easy to see, but there is cracking surrounding the support pad, the prop has been tightened too much.

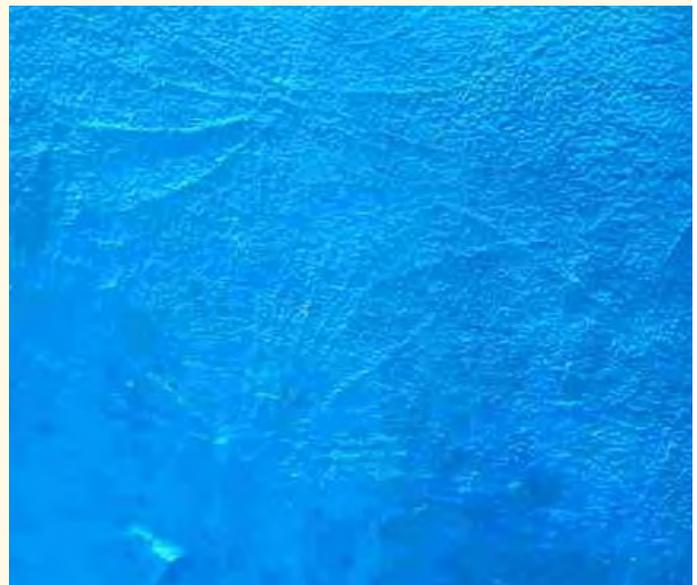
Again, not easy to see, but the star cracking under the antifoul indicates substantial impact damage,. The antifoul requires removal in order to further investigate
