Floors

Frames etc

Deck Problems

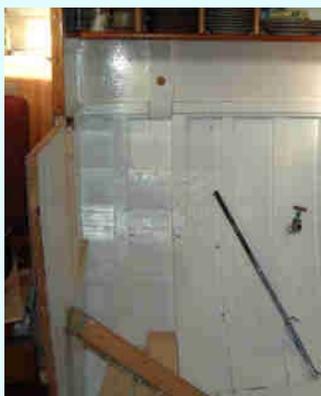
Internal framing

Perhaps this is not particularly serious provided it is just one here and there however, if there is a row of broken frames with the break on the same plank or line than these should not be allowed to remain. The cause of these can be varied and can be as simple as supporting the boat incorrectly when ashore (although still damaging and easily preventable) or as extreme as grounding or being crushed.

It is sometimes extremely difficult to see a broken frame because it may commonly appear just as a hairline crack across the frame but , is still a weakness.

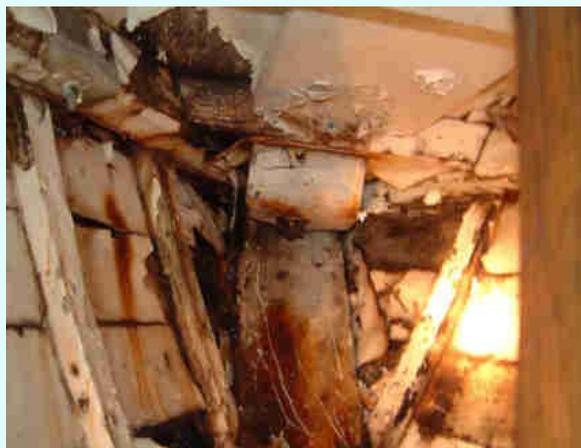
Photo showing fore end of stem , beam shelf & frames and breasthook just under deck in the prow

(this is a heavy section of timber running along the top of the frames just under the deck) carlins (these are sections of timber supporting the coach roof) and all of these are subject to deterioration caused by physical damage and decay. The beam shelf (deck shelf) is most prone to decay as it is just below the deck and in the case of any freshwater leakage long term, will deteriorate, this also applies to the Carlin which is subject to freshwater deck leaks.

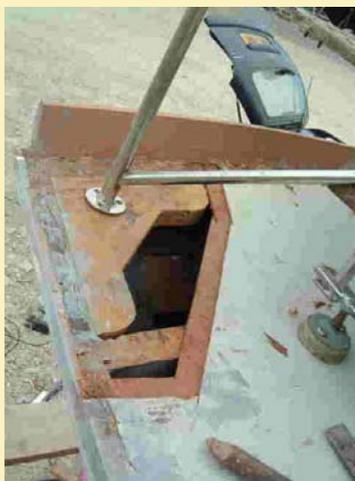
Plywood deck that had water penetration causing rot to plywood & quarter knee. New Knee fitted and preparing for new skin repair, note step joint on plywood

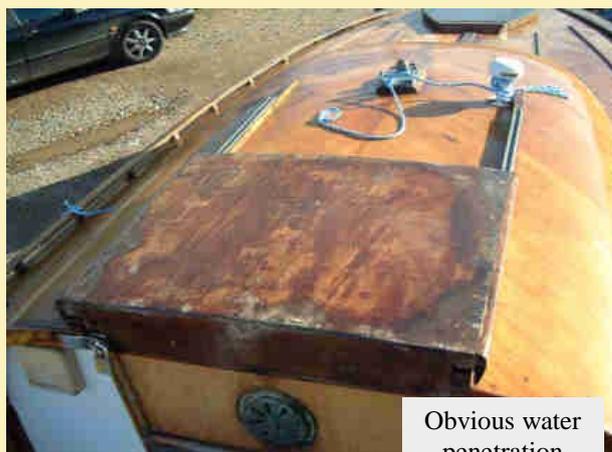
Obvious water penetration under the varnish

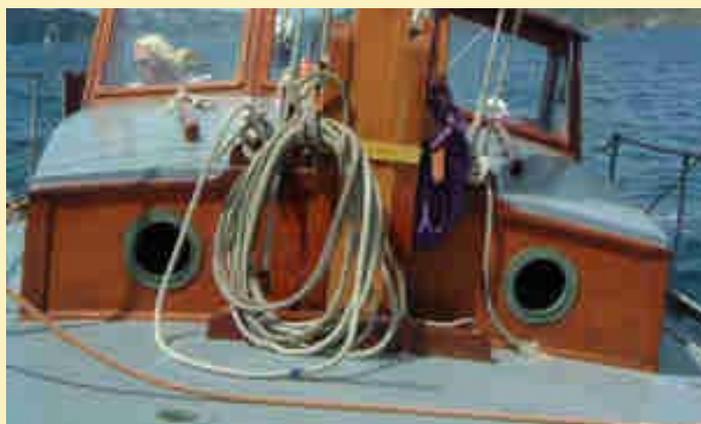
Solid coach roof problems will be in similar areas but generally to a lesser degree, more significantly at positions of vertical exposed end grain such as the fore and aft corners of the trunking. Solid timber coach roofs can also show long longitudinal splits particularly from fastenings for window frames and portholes.

Varnished coachroof. Often splits will emanate from the porthole fastenings.

These can vary in their severity and, in extreme cases would require repair. One possible repair is to set a router carefully on the length of the split, use a parallel cutter of appropriate width and machine an exact spline up which can be then glued into position and planed back this will make a virtually invisible repair.
