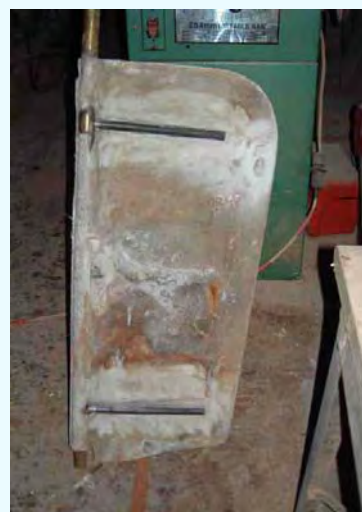
Internals of bronze stock/
mild steel tang rudder

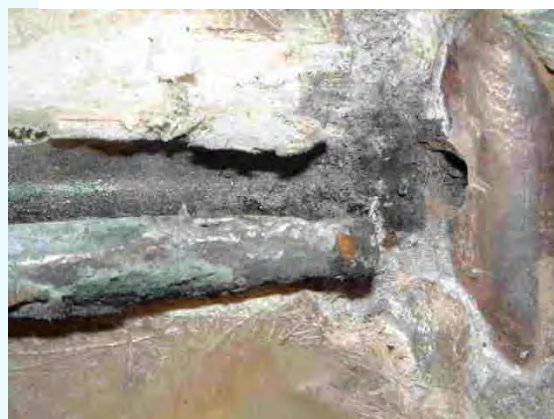
Close up of original corroded mild steel tang
just push fit into bronze stock drilling

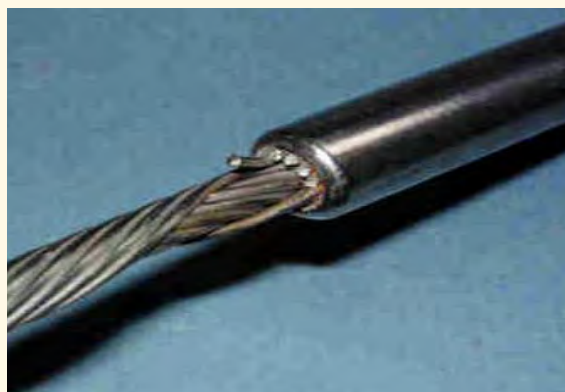
Stainless can fracture at work hardening points so look for hairline cracking at welds and flex points. Where the anodising coating has failed, usually at the foot of the mast and at places where abrasion has occurred, check for corrosion, which on alloy takes the form of white powdery coating and associated pitting which can be very deep. Unprotected alloy can corrode seriously.

Work hardened & fractured stainless wires at the swage
