Cored decks (and hulls)

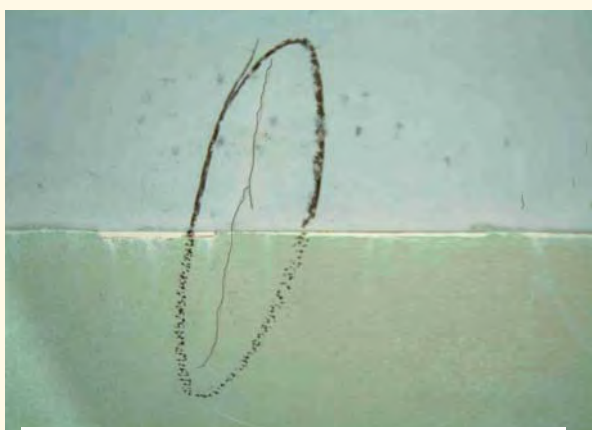
Longitudinal crack in gel coat on waterline.
This should be further examined

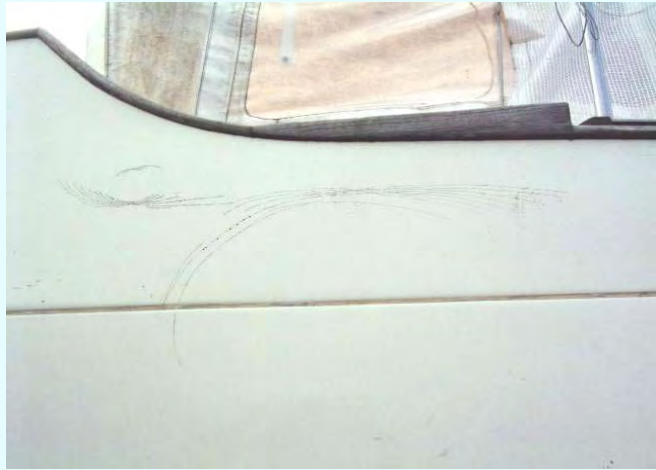
Hard spot cracking over the edge of the sidedeck which is level with the horizontal cracking

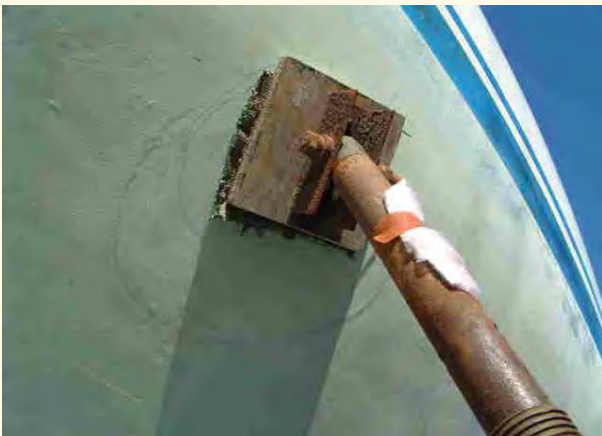
Not easy to see, but there is cracking surrounding the support pad, the prop has been tightened too much.

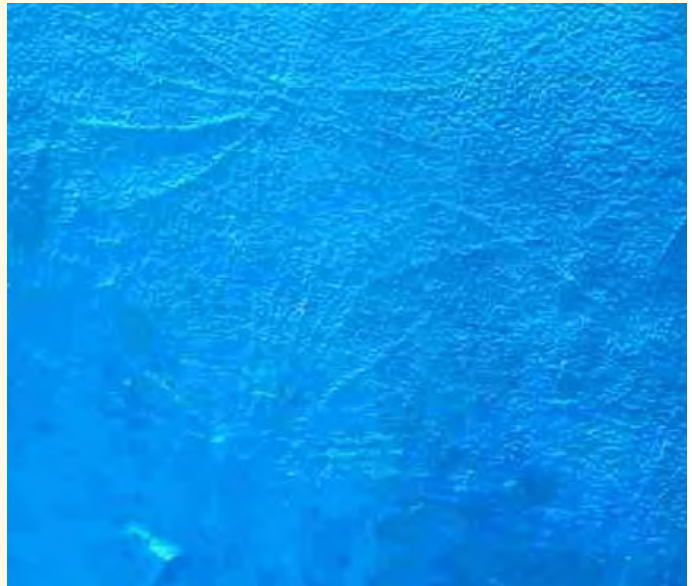
Again, not easy to see, but the star cracking under the antifoul indicates substantial impact damage,. The antifoul requires removal in order to further investigate
