## Osmosis

### A brief description of osmosis

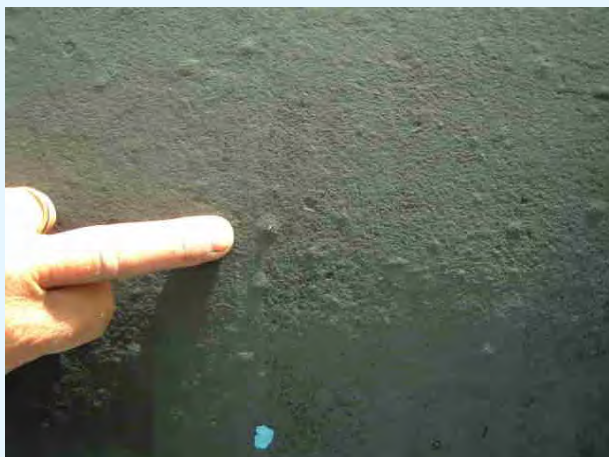
Moderate blistering, these average about 8mm dia, but can be as large as 13mm in advanced cases

More water continues to combine with them and increase their volume & density but as their escape route is blocked, they form blisters to make enough room, this slow process continues until they are released by gel coat removal and flushing all reaction chemicals away. In extreme cases the laminate can be

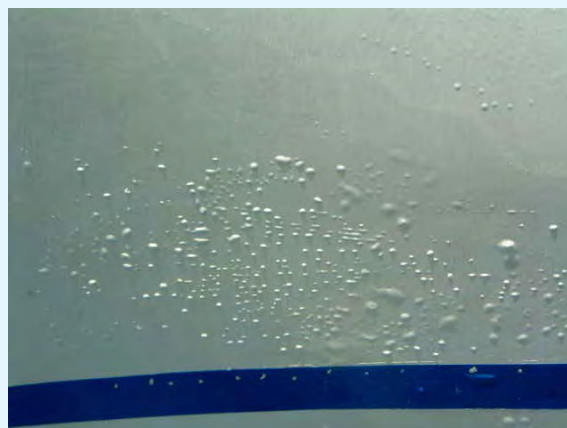
This is merely water beneath paint on resprayed GRP topsides, annoying but not a structural deterioration

Mis-diagnosis is unfortunately far too common, as noted above, not all blistering is osmosis.....

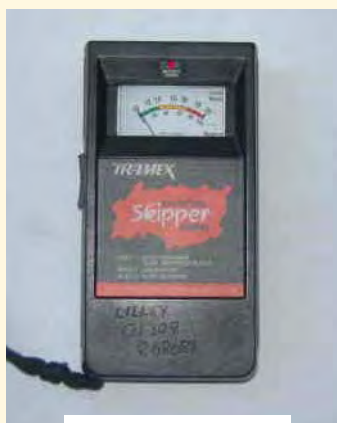
The most commonly used meters are the Tramex Skipper & the Sovereign. There are many other meters in use and these are just as reliable usually but the readings are not always easily compared to the two above. The Tramex has 3 selectable ranges of differing sensitivity and measures RF conductivity between two large pads. The display (similar to an analogue multimeter) is calibrated 10 – 20 on top side of the scale and 0 – 100 on the lower side of the scale i.e 10 on top is the same as 0 on bottom. and 20 on top is the same as 100 on lower side.

Usually the most sensitive range (no.2) is used to indicate whether the hull is suitable for epoxy coating as epoxy coating is more successful the “drier” the vessel is. Usually epoxy coating will not be professionally suggested if the residual readings are above about 15 on top, 50 on lower using

range 2. Range 1 starts where range 2 finishes, and range 3 starts approximately where range 1 finishes. Generally, a vessel that has residual readings less than 15 on top scale using range 2 is not likely to be suffering from any excessive degree of chemical activity in the hull.

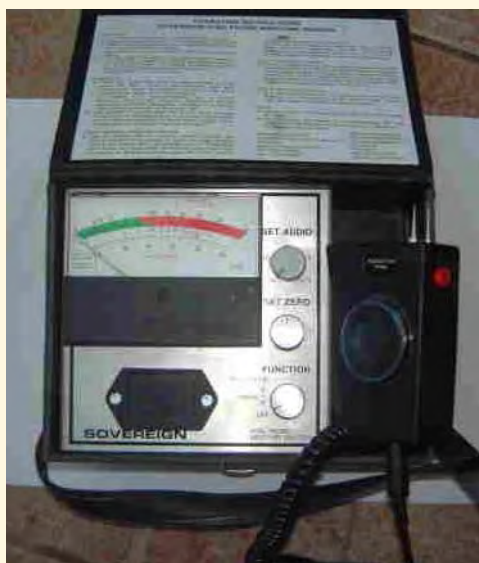
Sovereign Meter

The Sovereign meter only has 2 ranges, and the analogue scale is calibrated with various numbers but one of these is 1-100, which will be used by myself when referring to this in any survey. The drawback with this meter is that the only portion of the 1-100 reading that is used will be 0 – approximately 20 using the most sensitive range “A” Approximately 12 on the sovereign using scale A is equal to 15 (50) on the Tramex range 2..

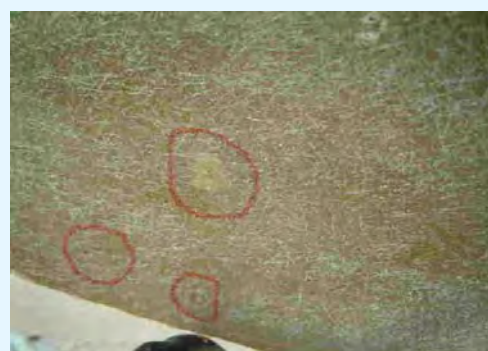
Voids beneath sandblasting easily seen
