Osmosis

A brief description of osmosis

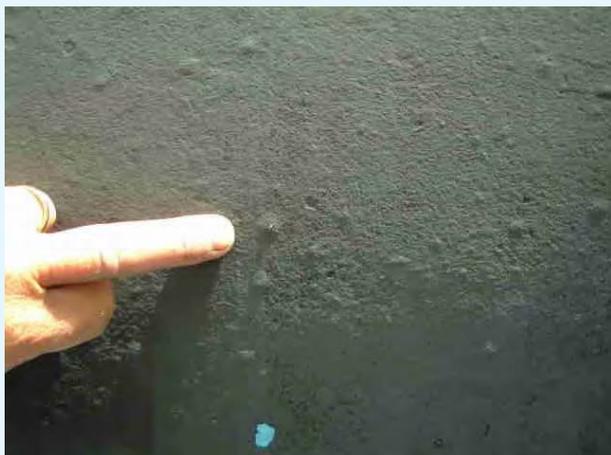
Moderate blistering, these average about 8mm dia, but can be as large as 13mm in advanced cases

More water continues to combine with them and increase their volume & density but as their escape route is blocked, they form blisters to make enough room, this slow process continues until they are released by gel coat removal and flushing all reaction chemicals away. In extreme cases the laminate can be

delaminate as the pressure of the blister fluid increases, when formation of blister fluid is deep within the laminate.

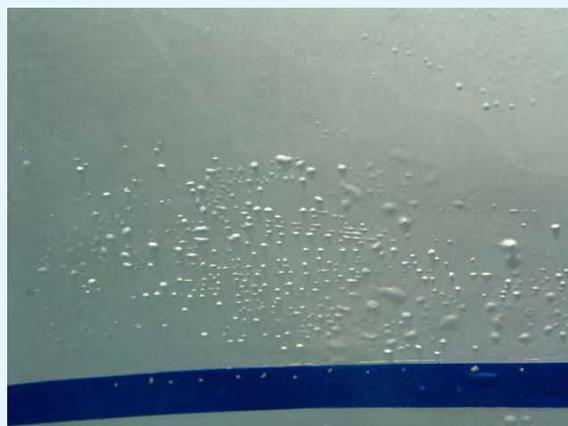
This is merely water beneath paint on resprayed GRP topsides, annoying but not a structural deterioration

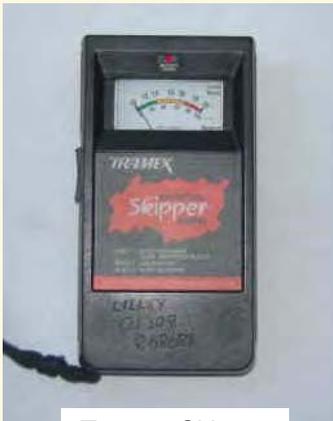
Usually the most sensitive range (no.2) is used to indicate whether the hull is suitable for epoxy coating as epoxy coating is more successful the “drier” the vessel is. Usually epoxy coating will not be professionally suggested if the residual readings are above about 15 on top, 50 on lower using

range 2. Range 1 starts where range 2 finishes, and range 3 starts approximately where range 1 finishes. Generally, a vessel that has residual readings less than 15 on top scale using range 2 is not likely to be suffering from any excessive degree of chemical activity in the hull.

A waterlogged skeg or rudder will often be off the scale on ranges 2, 1 and sometimes range 3, which does indicate high moisture content.

The most commonly used meters are the Tramex Skipper & the Sovereign. There are many other meters in use and these are just as reliable usually but the readings are not always easily compared to the two above. The Tramex has 3 selectable ranges of differing sensitivity and measures RF conductivity between two large pads. The display (similar to an analogue multimeter) is calibrated 10 – 20 on top side of the scale and 0 – 100 on the lower side of the scale i.e 10 on top is the same as 0 on bottom. and 20 on top is the same as 100 on lower side.

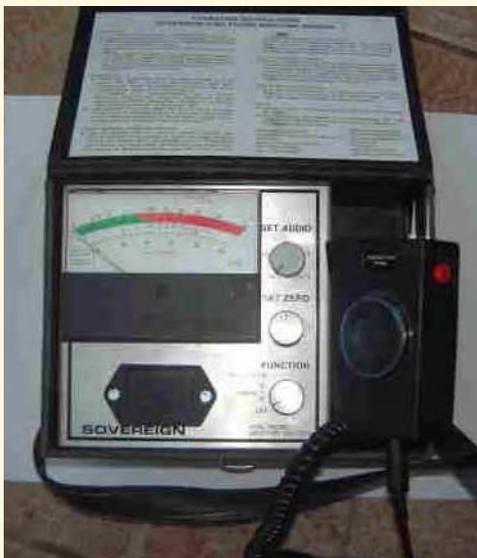
Sovereign Meter

The readings obtained on most vessels will usually be anywhere from the high end on range 2 through all range 1 and up to the bottom of range 3. which would be considered quite high.

The Sovereign meter only has 2 ranges, and the analogue scale is calibrated with various numbers but one of these is 1-100, which will be used by myself when referring to this in any survey. The drawback with this meter is that the only portion of the 1-100 reading that is used will be 0 – approximately 20 using the most sensitive range “A” Approximately 12 on the sovereign using scale A is equal to 15 (50) on the Tramex range 2..

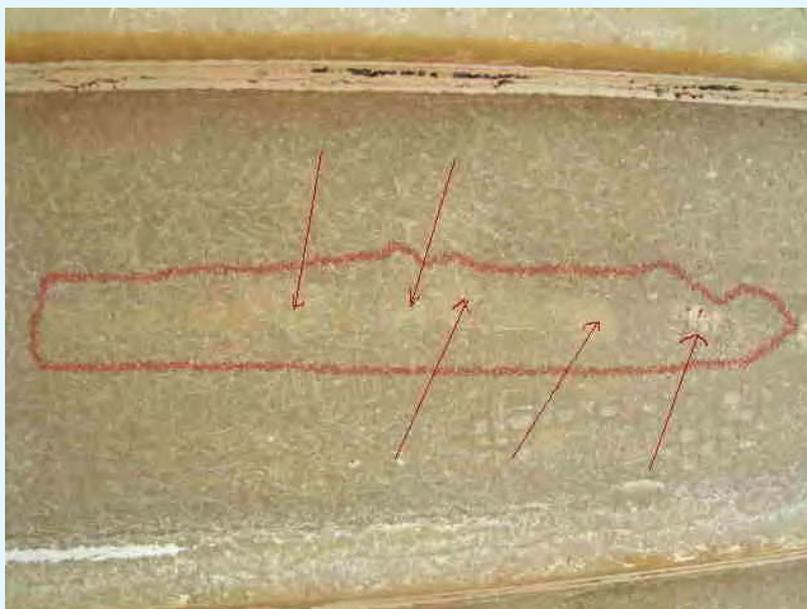
Sandblasted hull but note the barely visible voids under the thin skin that will fill with water eventually if not opened up

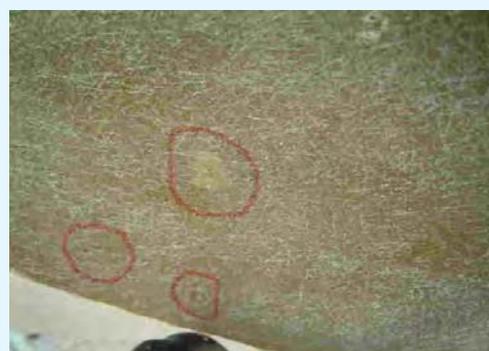
Voids beneath sandblasting easily seen
