Cockpit problems

Timber spars

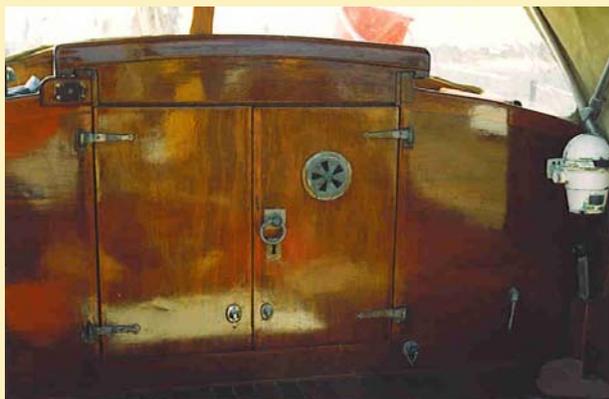
With a well maintained cockpit, water damage is obvious immediately.

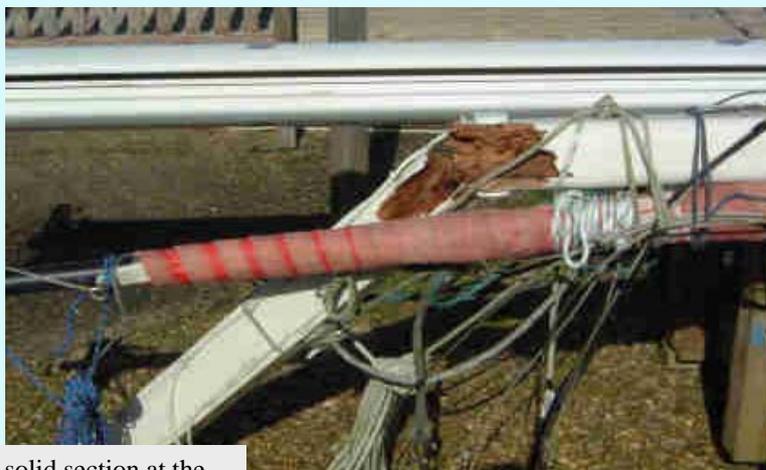
This is a hollow mast but a solid section at the bottom has been compromised over many years by water penetration. The white paint has obscured the continuing deterioration until it broke upon removal for survey

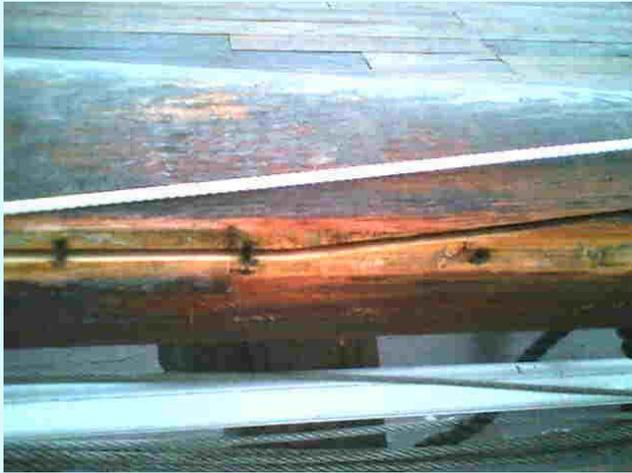
Here can be seen major glue line failure on a scarf joint extending onto the side section of boom

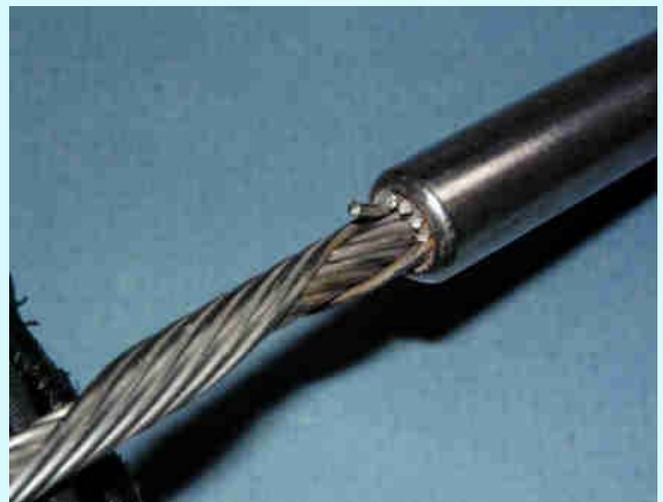
Stainless wire showing work hardened & broken strands at the swage. Galvanised does not suffer the same fault generally

The faults that stainless suffers as shown in the photo does not affect galvanised to the same degree.
