## Rudders

## Repairs to rudders

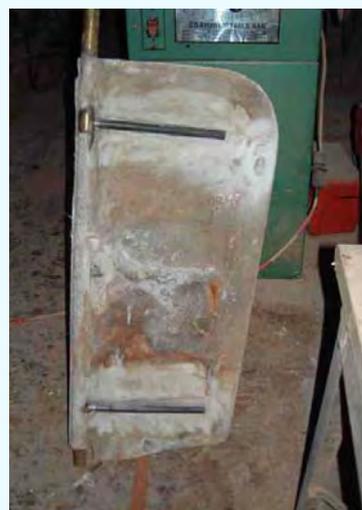
Internals of bronze stock/  
mild steel tang rudder

Usually the first indication will be cracking close to the stock position near the top of the rudder. The usual type of repair involves removing one face of the rudder; the face that does not have the tangs bonded to it is the usual one to remove. This will be cut with a cutting blade on an angle grinder in the appropriate position. The internal foam will be cleared out and the tang welds checked for both metal type and condition. It may be required to cut back some of the bonding to check these.

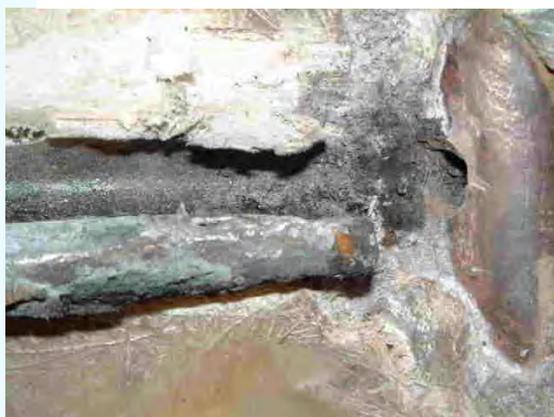
Close up of original corroded mild steel tang  
just push fit into bronze stock drilling

Once seawater has entered the rudder eventually corrosion can take place at the tang welds if dissimilar or non corrosion resistant metals have been, used causing failure. Hence the inspection checks for separation of the half mouldings and any evidence of corrosion staining leaking from the join as well as signs of delamination or excessive blistering.

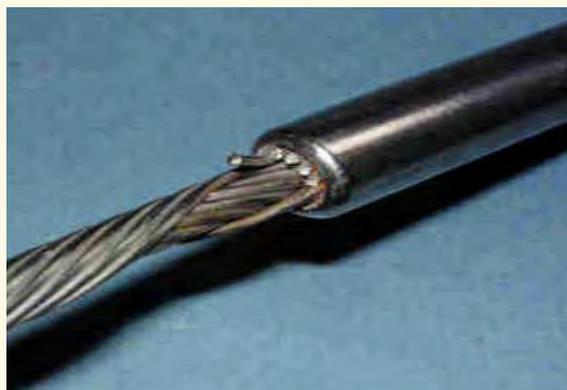
Work hardened & fractured stainless wires at the swage

Stainless can fracture at work hardening points so look for hairline cracking at welds and flex points. Where the anodising coating has failed, usually at the foot of the mast and at places where abrasion has occurred, check for corrosion, which on alloy takes the form of white powdery coating and associated pitting which can be very deep. Unprotected alloy can corrode seriously.
