WELCOME TO  
**SeaSurveys**  
MARINE SURVEYORS

## Cored Deck Failures

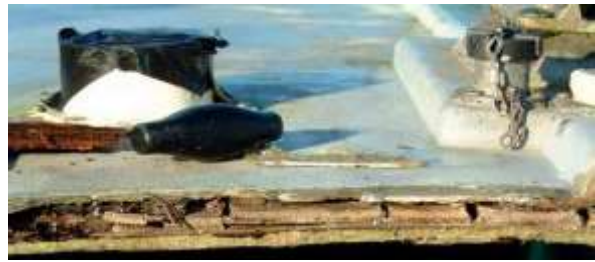
If a high presence of water has entered the core from leaks on deck, this can cause breakdown and failure of the core. Always ensure that deck fittings are maintained and any areas of strain or damage are attended to that may allow water into the core. In the case of serious breakdown of the inner core, whether it be balsa wood, polyurethane foam or plywood there is no option other than complete removal of this core. It is generally not feasible to remove the inner laminate to gain access to the core so most cases the outer laminate is removed. In the case of a failed deck core for instance, a considerable section of outer skin of deck will be removed by using a cutting blade on an angle grinder or something similar and cutting around the physical limits of the moulding. This section is then completely removed and full access to the underlying core can be made. Once reparations to the core are complete depending upon the type of core present, the outer section of deck will be

refitted and overlaid with epoxy resin and glass cloth along the boundary-connecting join.

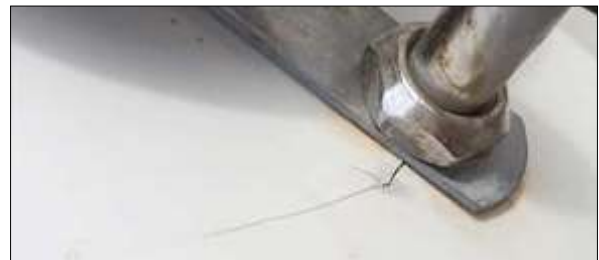
*1 Stress cracks emanating from a baseplate mounting*

vessel taking water through these, the exception being, in some cases where cracks around stanchion bases are noted, it has been no that although the crack looks innocuous, it has allowed continual seepage right through the laminate because the hairline crack is full thickness in the very rare cases.

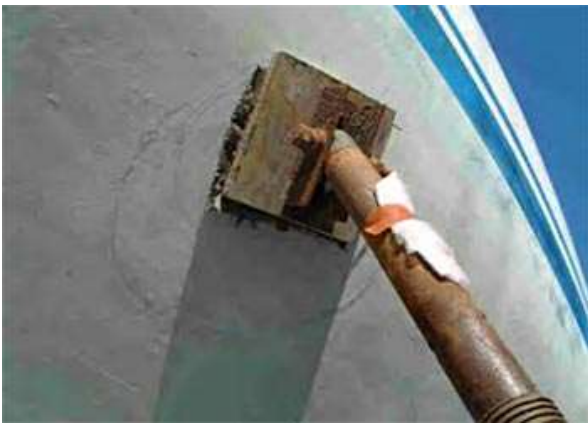
Other gel coat cracks can be indicative of weak structure and this will often be found in places of high localised loadings such as stanchion bases, rigging U bolt support areas, and other highly stressed areas.

*2 Stress cracks emanating from a baseplate mounting*
