**Timber constructional problems**

**Electrolytic damage**

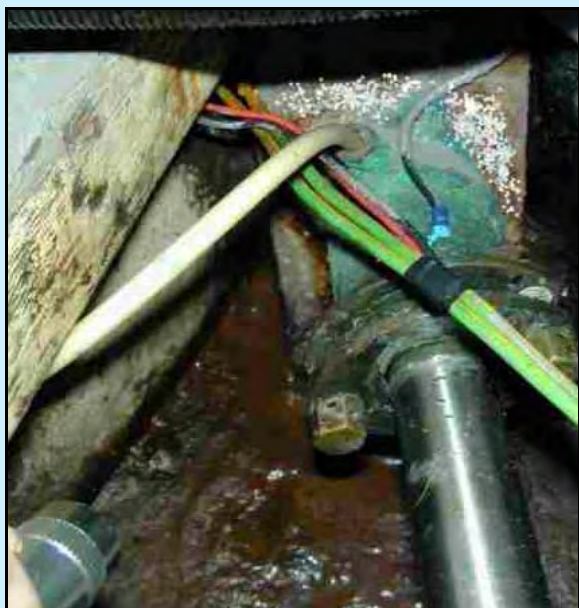
Surrounding the stern gland /deadwood junction is the typical crud indicating electrolytic damage is present. The timber is damaged here, note the wire connection just visible on the shaft outlet end of the top of the gland. This goes to an anode.

This electrolytic solution becomes concentrated at the point of the connections and inevitably the metals being sacrificed or protected. This is even more pronounced on the inside of the vessel where the solutions are not been diluted by external seawater, but being further concentrated by damp non flushed conditions. The usual major problems on timber vessels are firstly the planking in at the position of the anode particularly anode fastenings where the planking will go soft and irrecoverable and even more drastic in some cases, where the wiring is connected to the internal stern tube and rudder tube.

The normal sign of significant electrochemical damage is a build-up of white crud similar to that which occasionally occurs on battery terminals surrounding the metal parts being protected and the anode wiring terminals. If this type of crud is seen by then, damage is already occurring.

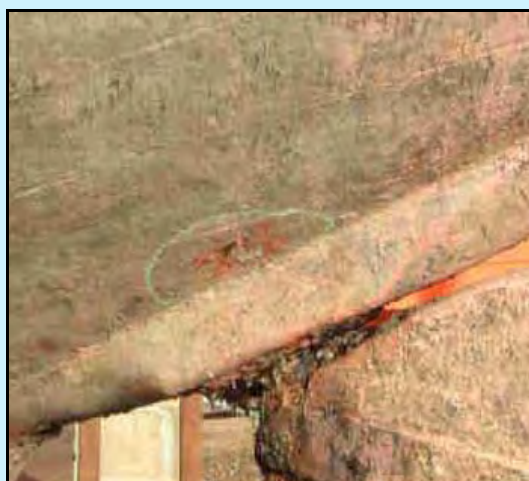
Early electrochemical damage caused by Copper Fastening contacting steel rudder tube & creating electric cell with softening to the plank hood end

Other electrochemical damage occurs merely through localised fastening corrosion such as keelbolts, skin fittings etc where the timber softens around the fastening somewhat.
